# Mosaics In Situ Project

## ILLUSTRATED GLOSSARY

Definitions of terms used for  
the graphic documentation of in situ floor mosaics

Developed by the Getty Conservation Institute and  
the Israel Antiquities Authority

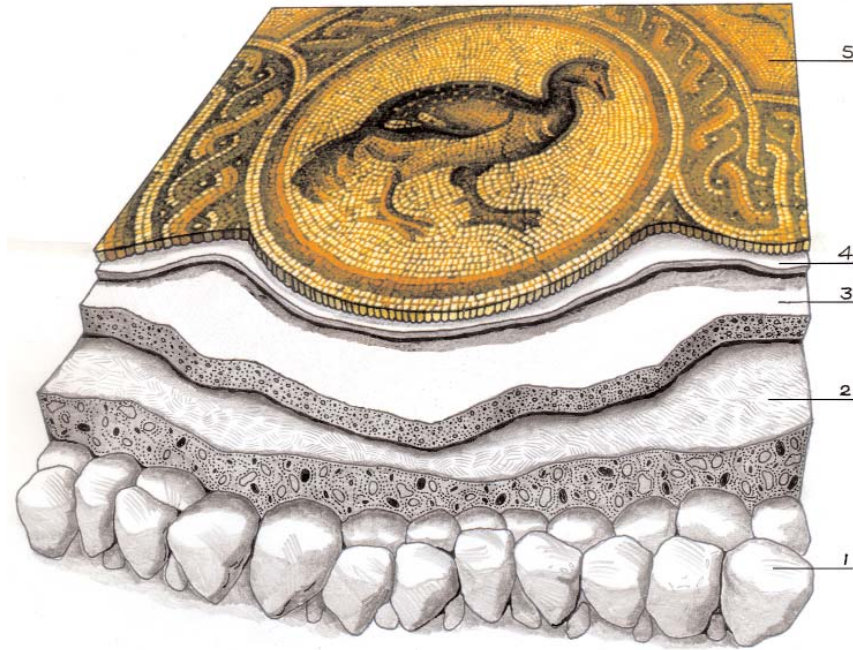
# MOSAIC STRATIGRAPHY

The following stratigraphy is adapted from ancient literary sources. It is to be used only as a general reference in this document. In practice, all mosaics do not necessarily display this stratigraphy.

A mosaic can be built on natural ground made of soil or rock, or on top of a previous pavement. The mosaic itself is composed of a variety of foundation or preparatory layers and a layer of tesserae.

**1 - Statumen** - First preparatory layer which is made of large stones laid on the ground, previously leveled and rammed. This layer only exists if the mosaic has been constructed on a natural soil.

**2 - Rudus** - Second preparatory layer which is spread over the statumen. This layer is made of a lime mortar with large aggregates.

**3 - Nucleus** - Third preparatory layer which is spread over the rudus in a thinner layer. The nucleus is made of a mortar with fine aggregates.

**4 - Bedding layer** - Fourth preparatory layer of mortar which is very rich in lime, and thinly applied in small sections over the nucleus. Tesserae are inserted in this layer before the mortar sets.

**5 - Tessellatum** - Layer which constitutes the mosaic surface and is composed of tesserae and mortar filling the interstices between them.

Stratigraphy drawing by Haim Kapschitz, modified by Elsa Bourguignon © J. Paul Getty Trust

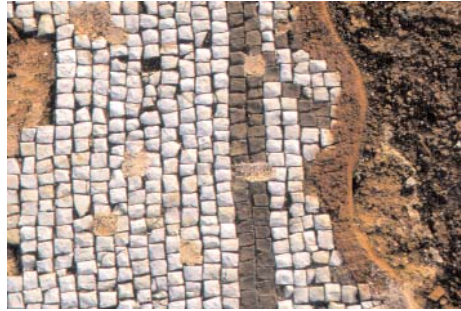
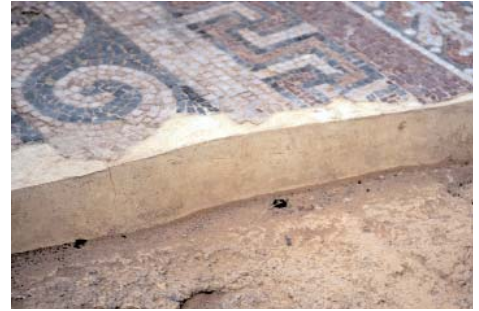
### EDGING REPAIR

Mortar reinforcing a mosaic border or edge.

Within a single mosaic, edging repairs can be classified according to their color, surface texture and material utilized.

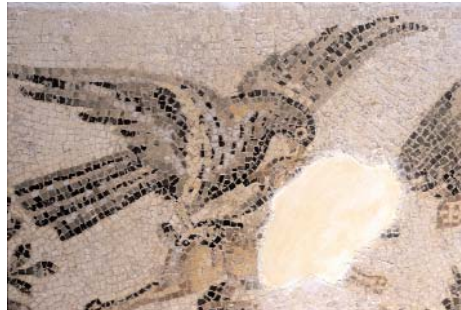
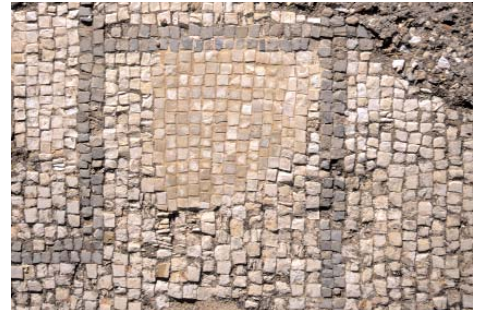
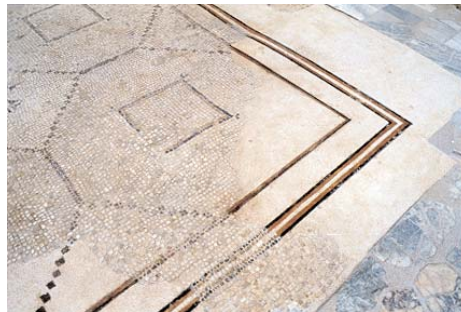
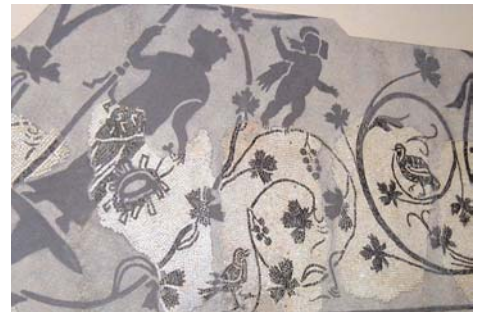
### FILL

Area where the original tessellatum is missing and the resulting lacuna has been filled, either in antiquity or in the modern period.

Within a single mosaic, fills can be classified according to their date, color, surface texture and material utilized; e.g. mortar alone or mortar with various materials bedded in it, such as tesserae, larger stone or ceramic fragments.

Fills using tesserae or attempting to indicate the design with other materials may be termed reintegration.

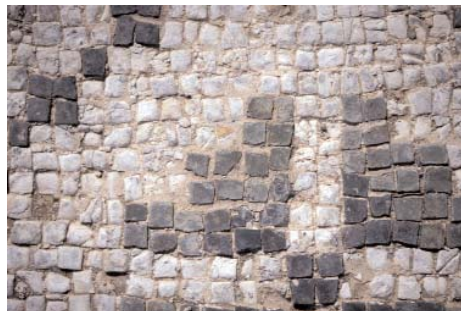
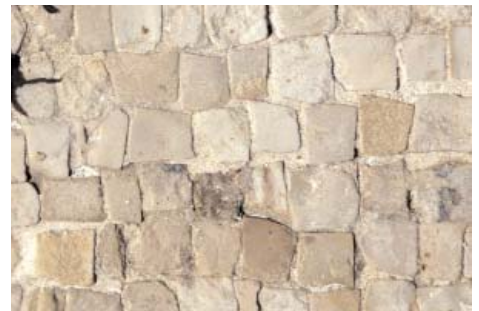
### FILL BETWEEN TESSERAE

Area where the original mortar in the interstices between the tesserae has been replaced.

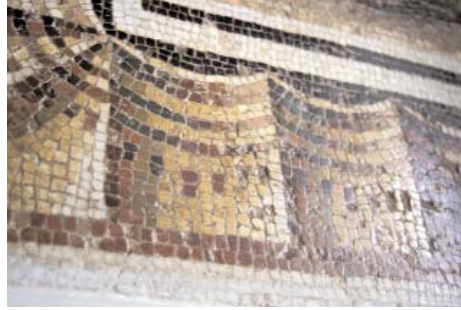
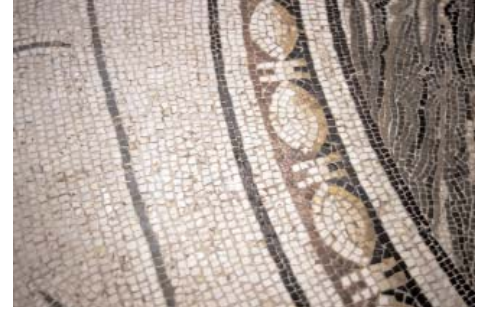
### TREATED SURFACE

Area of the tessellatum where material has been applied intentionally to consolidate, protect or enhance the color of the mosaic surface, such as wax, chemical consolidant.

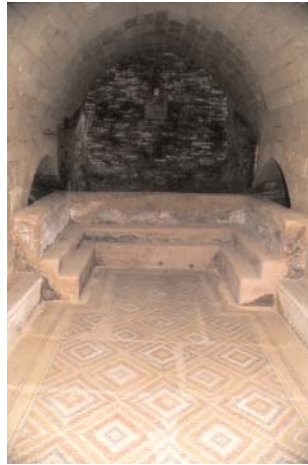
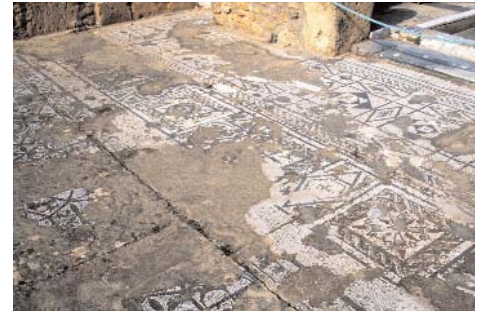
### RE-LAID AREA

Part of the tessellatum which has been detached from its preparatory layers, in sections or in one piece, and re-laid in situ on a new support.

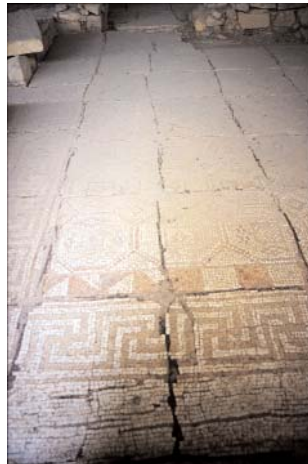
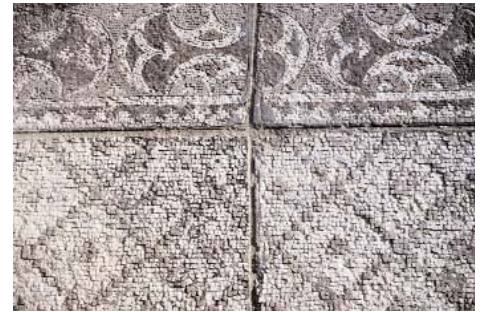
### JOINTS BETWEEN RE-LAID SECTIONS

Spaces between the sections of a mosaic that has been cut, detached, and re-laid in situ.

The cuts may or may not follow the design of the mosaic. Joints may have been left empty or filled with a material (mortar, tesserae, etc.) to restore the continuity of the mosaic surface.

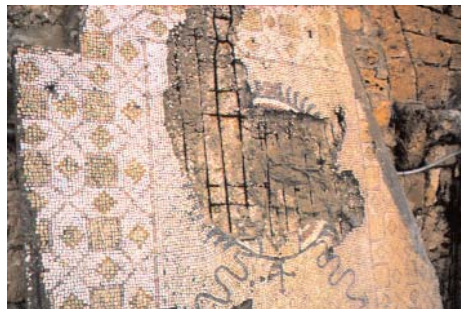
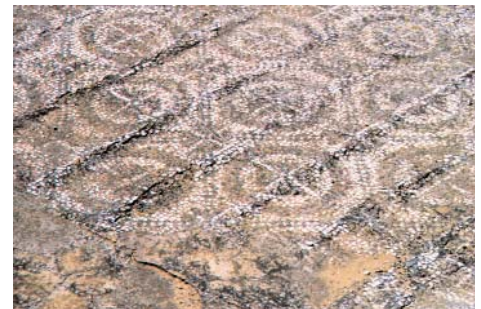
### METALLIC ELEMENTS

Structural reinforcements belonging to the new support of a re-laid mosaic.

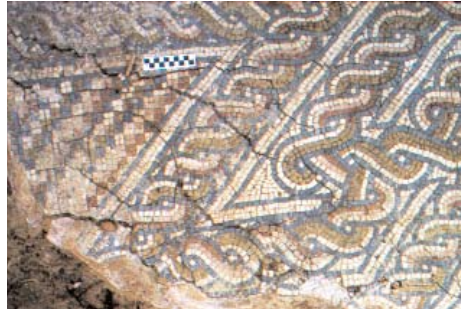
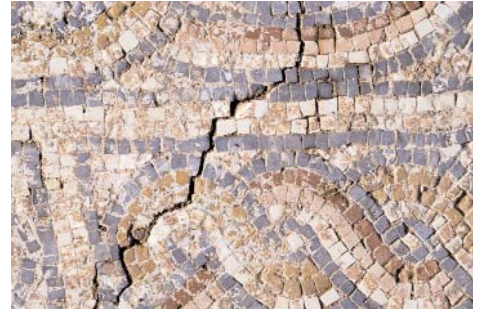
### CRACK

Linear breaks visible at the surface of the mosaic, which may also penetrate into its lower layers.

The word fracture is also commonly used to describe this condition.

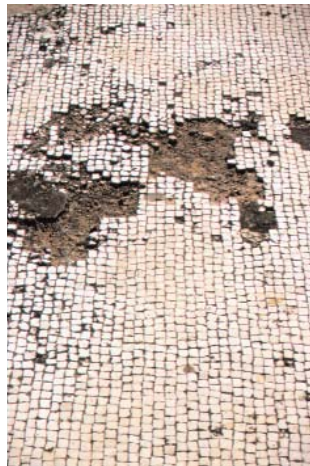
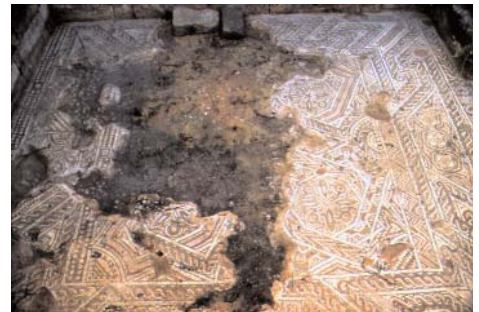
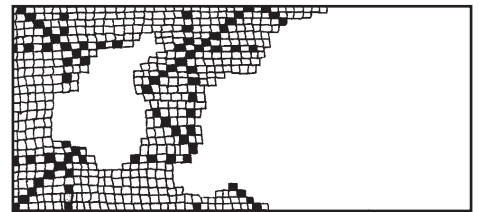
### LACUNA

Area of the mosaic where the tessellatum is missing.

Within a single mosaic, lacunae can be classified according to their depth; for example lacuna of tessellatum, bedding layer or nucleus.

The word loss is also commonly used to describe this condition.

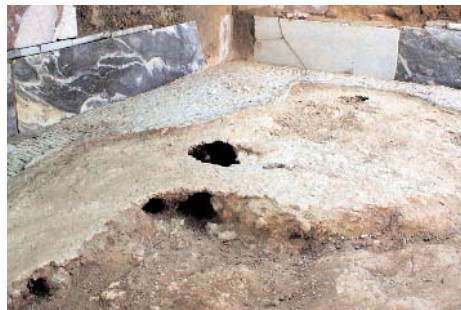
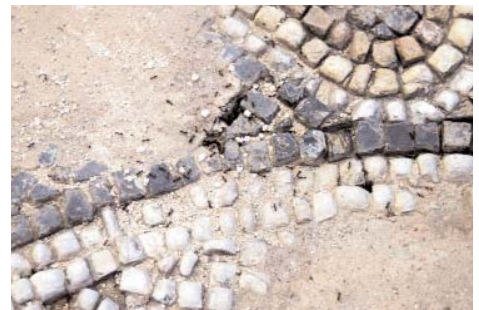
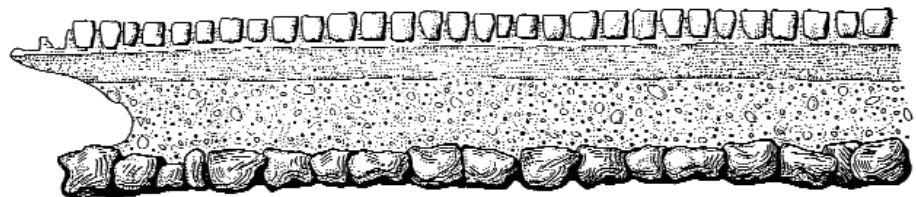
### CAVITY

Area of sub-surface loss.

Cavities can be due to water erosion or animals, including insects, burrowing.

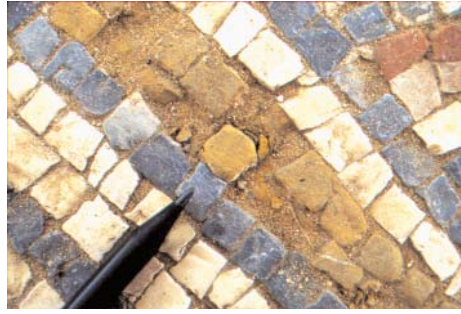
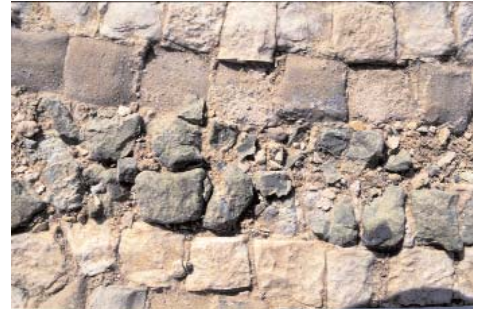
### DETACHED TESSERAE

Tesserae which are still in their original location but have lost adhesion to the bedding layer and, as a result, move when lightly touched.

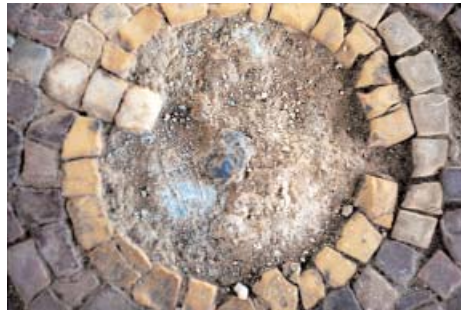
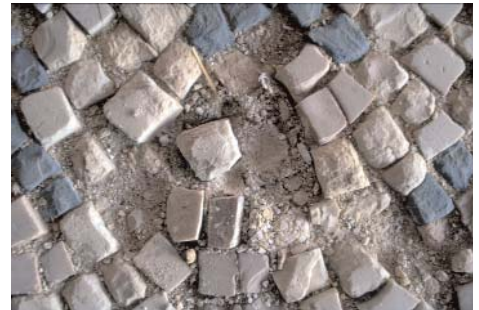
### DETERIORATED PREPARATORY LAYERS

Loss of physical integrity within one or more layers of mortar supporting the tessellatum as manifested by cracks, disaggregation, erosion, etc.

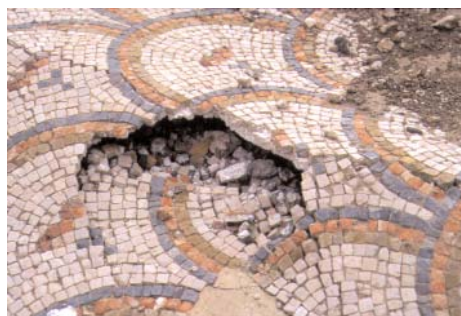
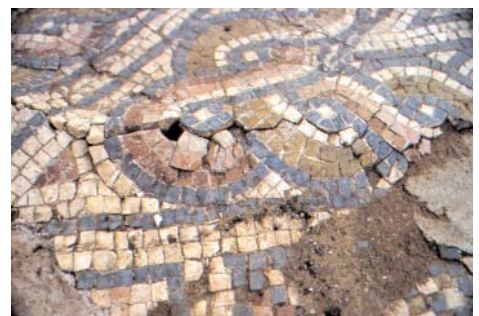
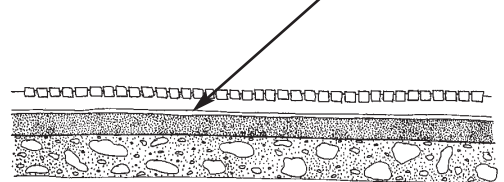
### DETACHMENT BETWEEN MOSAIC LAYERS

Lack of adhesion between two layers of the mosaic.

A detachment is not always visible and can be detected by the corresponding hollow sound produced when the surface of the mosaic is tapped.

Detachment with void

Detachment without void

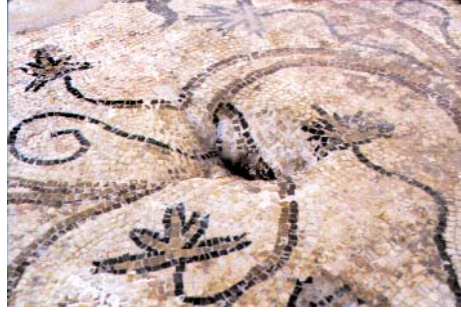
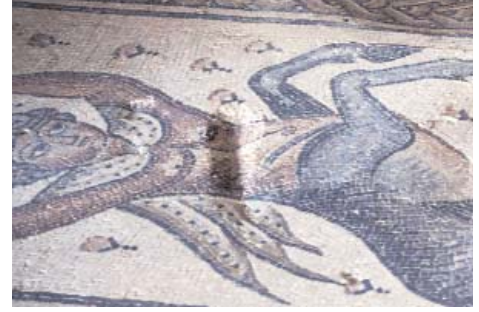
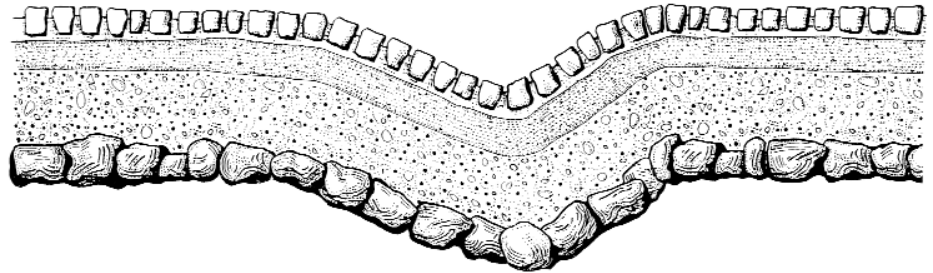
### DEPRESSION

Downward deformation of the mosaic below its original surface level.

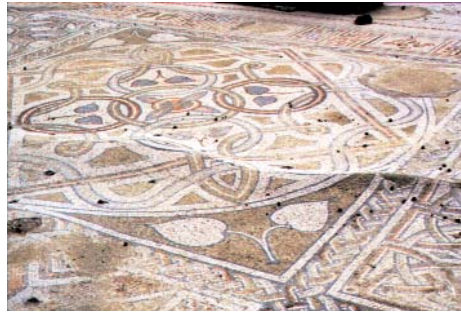
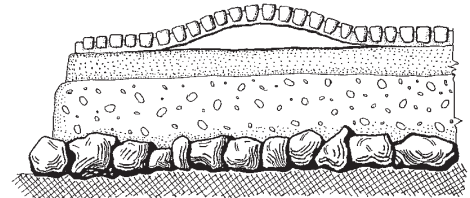
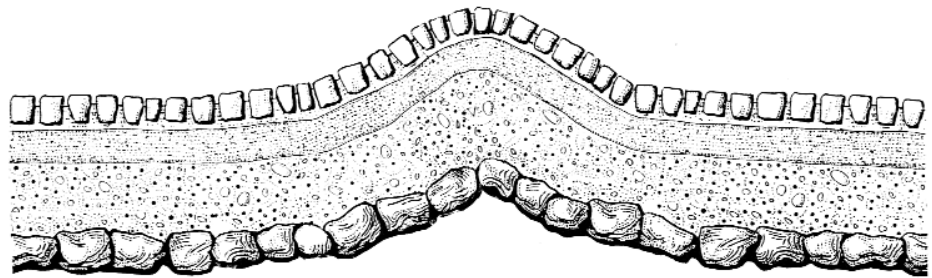
### RISE / BULGE

Upward deformation of the mosaic above its original surface level.

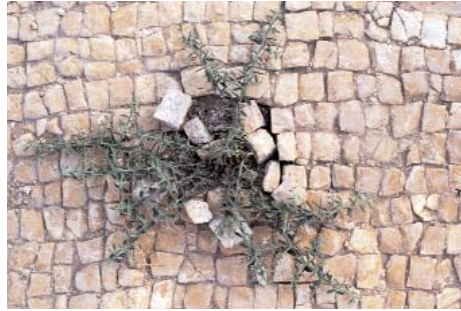
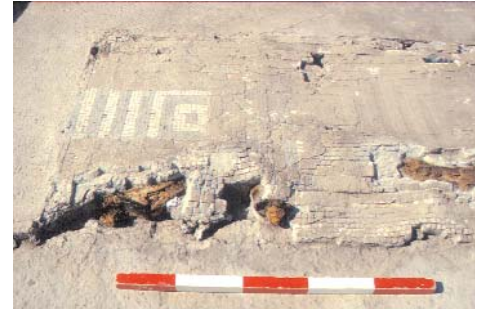
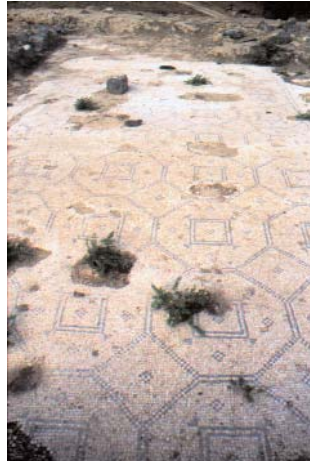
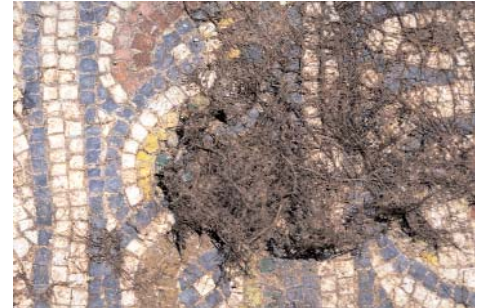
### PLANT INTRUSION

Vegetation, such as weeds, grasses, bushes and trees, and their associated roots which are present under, within or on top of the mosaic.

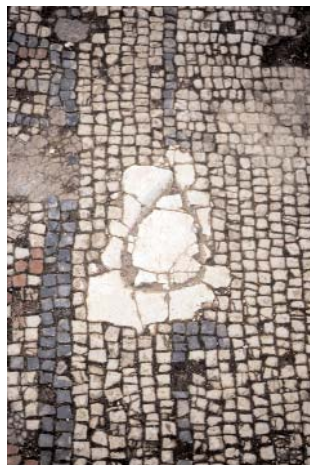
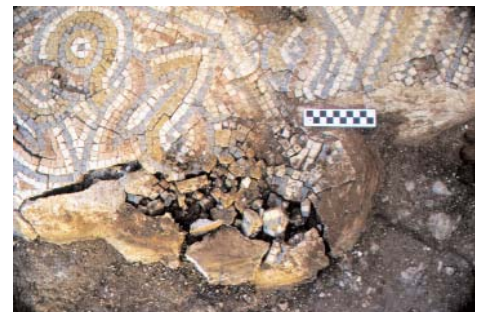
### DETERIORATED REPAIR MORTAR

Loss of physical integrity of edging repairs or mortar fills as manifested by cracks, disaggregation, erosion, etc.

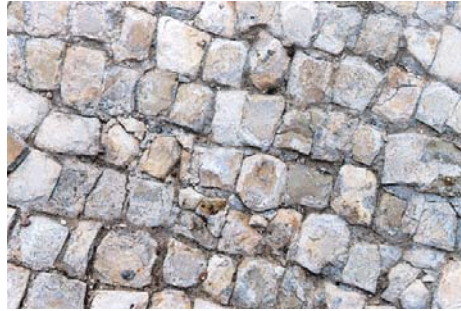
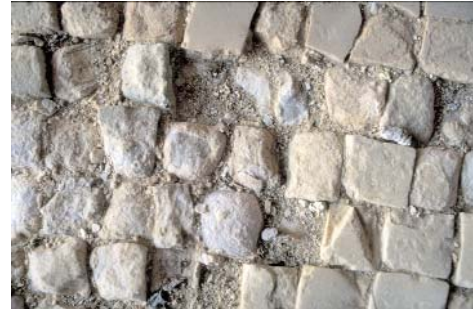
### DETERIORATED TESSERAE

Tesserae which have suffered a loss of material or of physical integrity.

Deteriorated tesserae can be described more precisely as Disaggregated, Eroded, Exfoliated, Fractured, Pitted, etc.

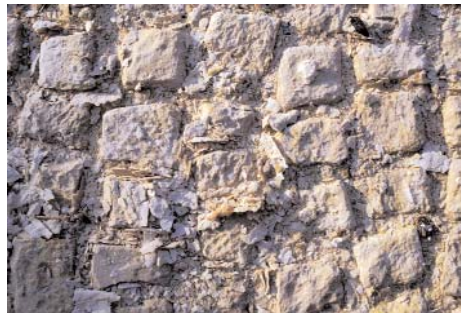
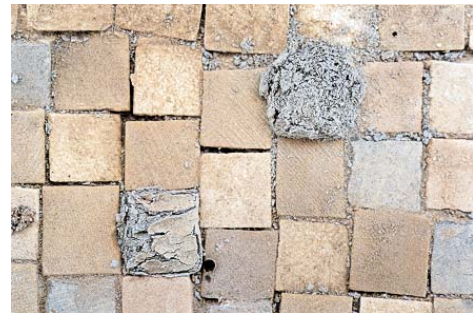
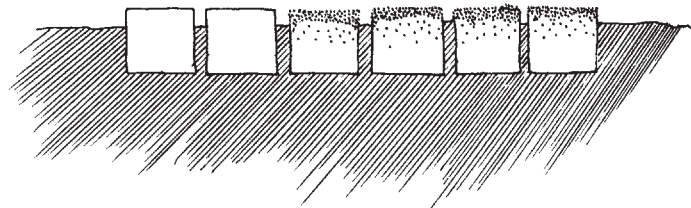
#### DISAGGREGATED TESSERAE

Tesserae displaying loss of cohesion of their surfaces, which have disintegrated into powder or small grains.

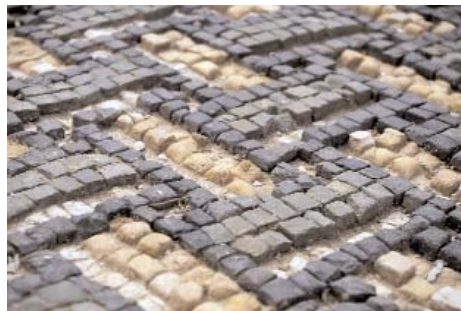
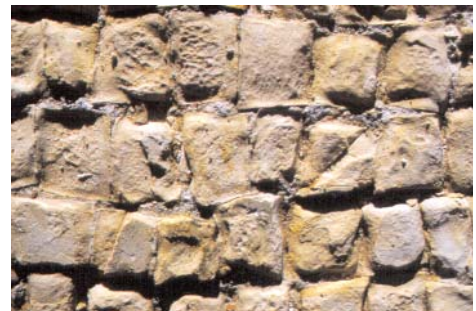
#### ERODED TESSERAE

Tesserae displaying a worn or abraded surface.

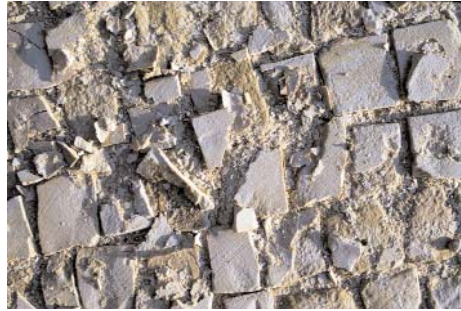
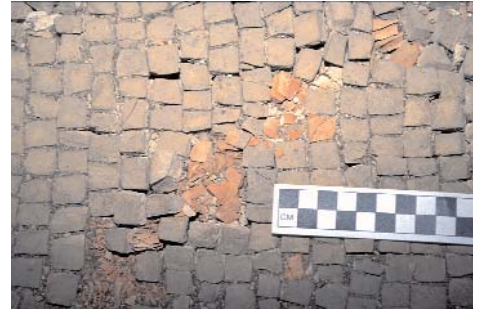
### EXFOLIATED TESSERAE

Tesserae displaying detachment or loss of layers, parallel or perpendicular to the mosaic surface.

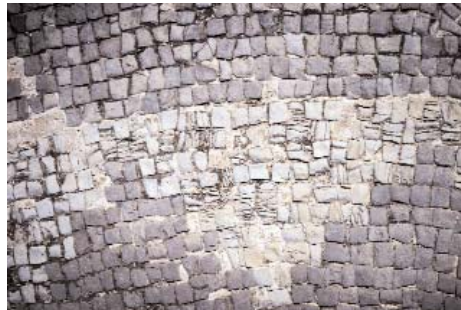
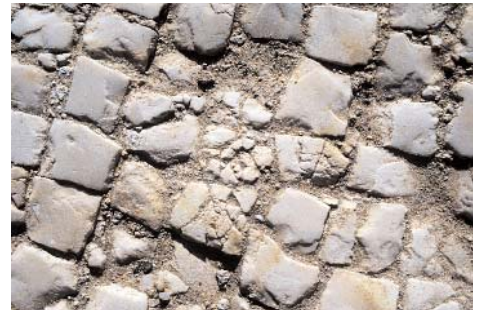
### FRACTURED TESSERAE

Tesserae displaying linear breaks or network of breaks through their matrix.

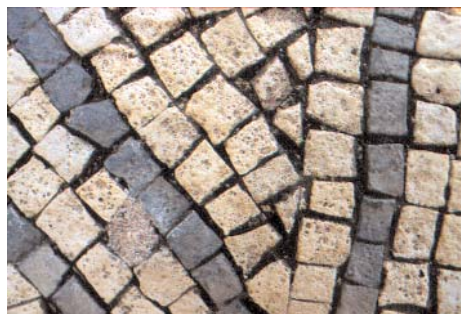
### PITTED TESSERAE

Tesserae displaying numerous small, rounded cavities on their surface.

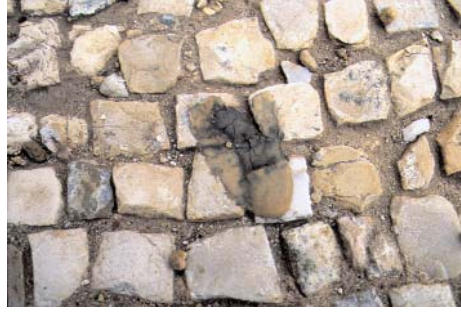
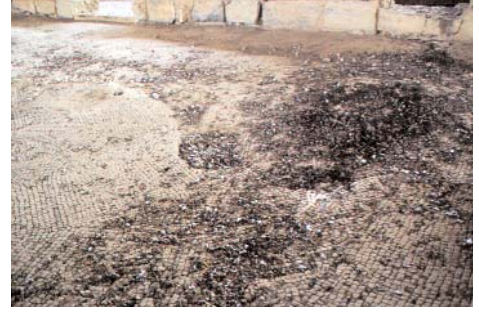
### DEPOSIT

Accumulation of extraneous material of various types, such as soil, sand, animal droppings and vegetal materials, of variable thickness, and poor adhesion to the mosaic surface.

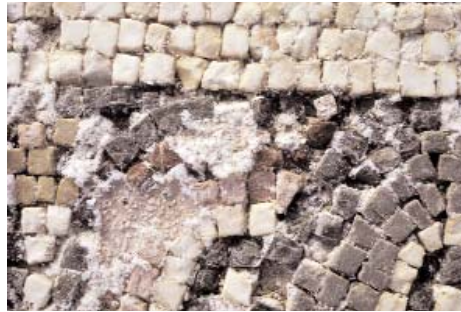
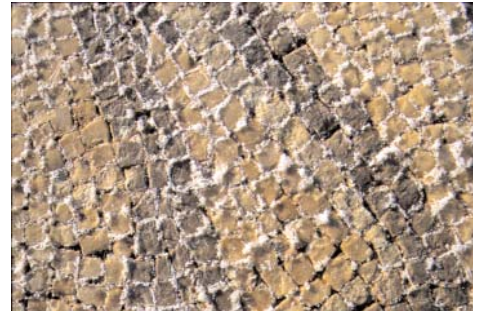
### EFFLORESCENCE

Formation at the mosaic surface of a loosely adhering substance, generally white and crystalline, powder-like or whisker-like in appearance.

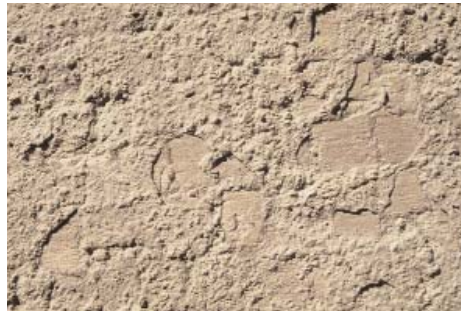
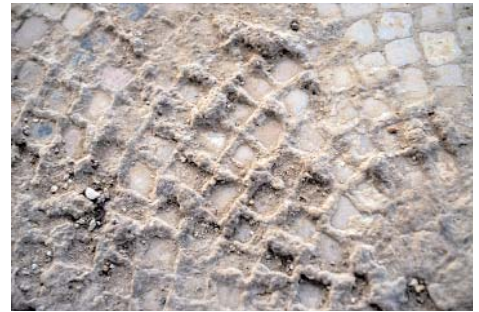
### INCRUSTATION

Mineral crust formation adhering to the mosaic surface, often hard and compact, and of variable thickness and extent.

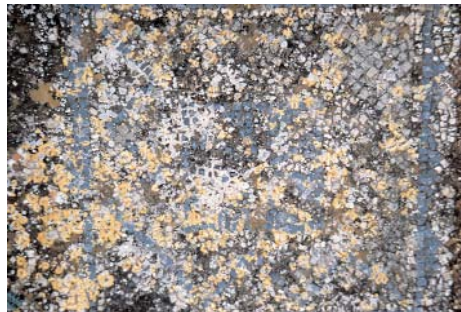
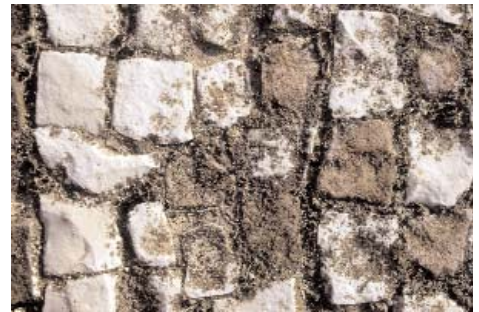
### MICROBIOLOGICAL ORGANISMS

Small organisms of various colors and forms, living or dead, such as fungi, algae, lichens, mosses, or bacteria, which adhere to the mosaic surface.

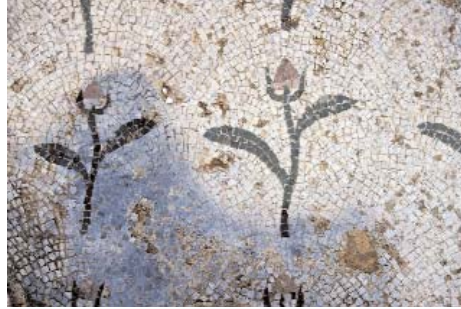
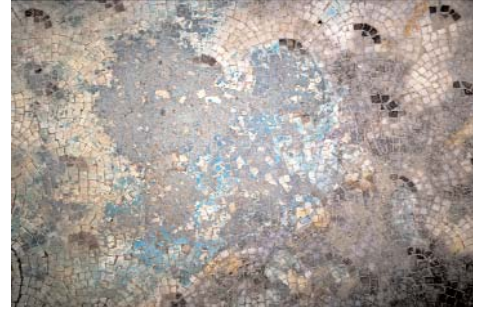
### COLOR ALTERATION

Alteration of the mosaic surface characterized by a localized change in color.

Color alterations may be termed more precisely metallic stains, fire damage, graffiti, etc.

*Right photo:* Nahariya, Israel. Bronze stains on mosaic from fire in church. August 1997. Francesca Piqué © J. Paul Getty Trust
